Template for a statement of significance

The Parish of Craswall lies on the north east slope of the Black Mountains and, in character, represents a transition from the narrow, steep sided valleys of the Black Mountains to the gentler hills sloping down to the Golden Valley and the Hereford plain. It is the most rural parish in Herefordshire with an approximate area of 21 square kilometres and a population (as recorded in the 2011 census) of just 153 people in 60 households. Archaeological evidence of people using and living in the area is found mostly on higher ground and, within the parish, comes from the Cefn Hill on the north east boundary. It is probably significant, therefore, that the church of St Mary is also situated on a fairly elevated spur looking down the Monnow Valley, just above the confluence of the Cwm y Canddo and Monnow rivers. Though there is no specific evidence for a very early foundation, the location of the church would seem to speak of great antiquity.

St Mary's is a Grade II* listed building (List number 1078203), currently on the Heritage at Risk register. The nave and chancel, which occupy the eastern end of the building, date from the 14th-15th century

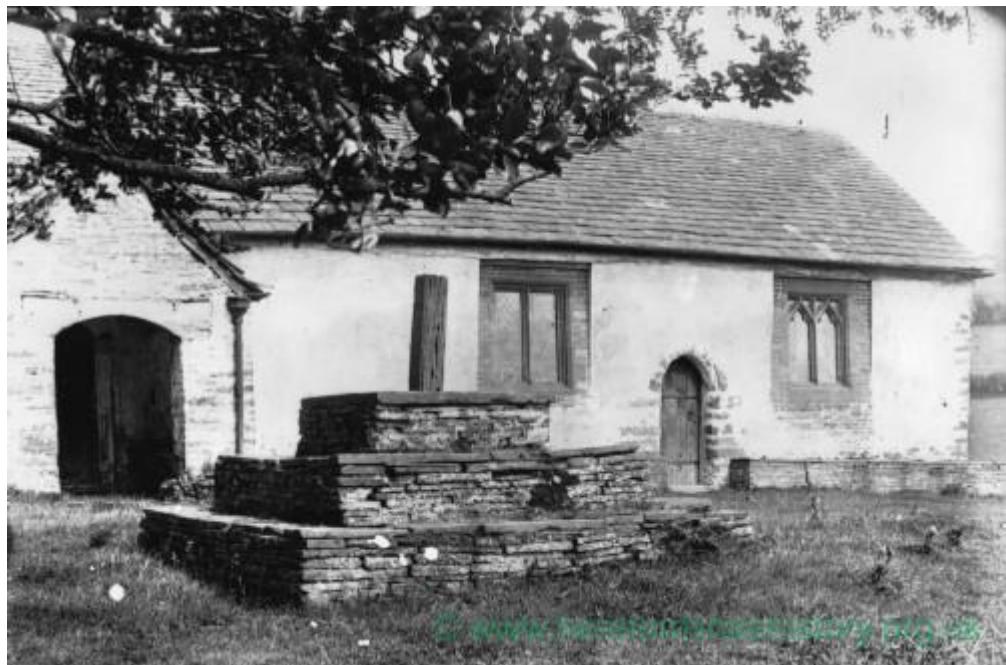
Alfred Watkins photograph of St Mary's from 1928 from a collection held by the Herefordshire Libraries.

The porch, which was probably added at the same time as the schoolroom, is quite typical of the area. The outer doorway has been altered since the Alfred Watkins photograph, with a wooden lintel replacing a shallow stone arch. The roof is a braced collar beam type with the curved braces forming half round arches. There are stone slab shelves along either wall and in the east wall there is a recessed scoop with a quatrefoil head and back. The inner doorway, which has moulded jambs and a three centred head, is of a much earlier origin. This doorway, and the one to the east of it opening into the nave, possibly came from the ruins of Craswall Priory.

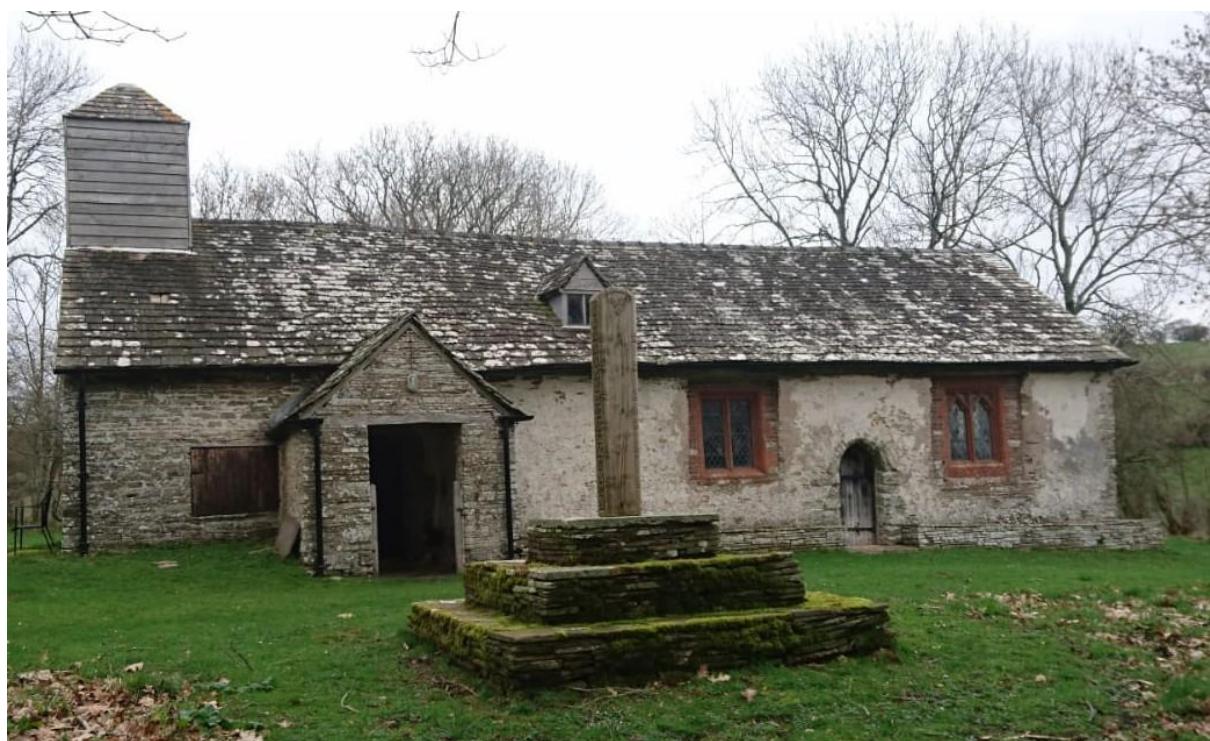
A view of the church taken in 2023 from a similar location, showing the south elevation.

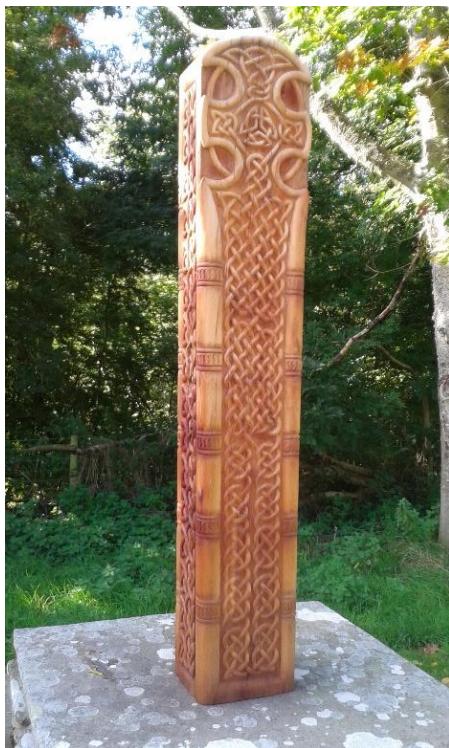
The Celtic cross carved by Ken Watkins.

It is an exact copy of the 7th-9th century Neaedd Siarman stone cross now in the Brecknock Museum and Art Gallery, Brecon.

Opposite the south porch there is a square plinth consisting of three steps of dry-stone construction with a socket in the centre for a preaching cross. Similar bases may be seen at St Margaret's and Michaelchurch Escley. Craswall's stone base now has a Celtic cross carved in yew wood from the nearby Michaelchurch estate by the former churchwarden Ken Watkins and dedicated in 2015.

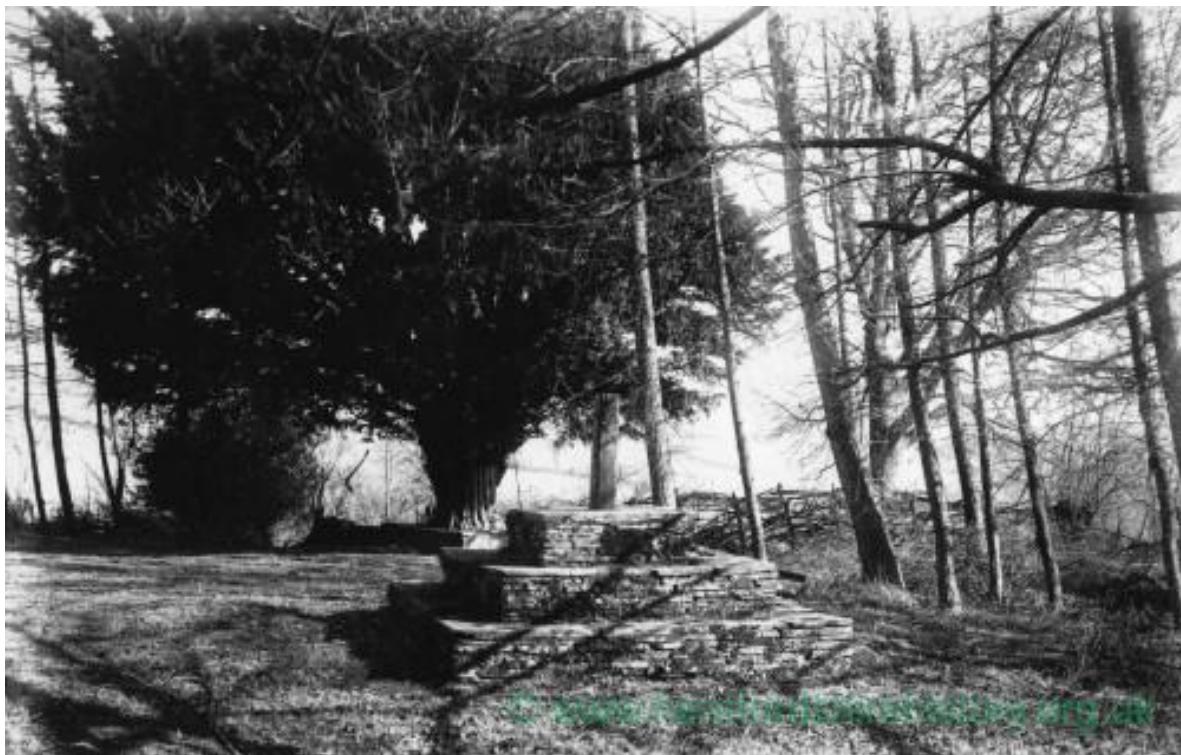
Close to the churchyard boundary on the southeast side, there is a fragment of an ancient yew tree, still alive, although now much overshadowed by hazel trees. A report on the Ancient Yew Group's website from November 2016 by Paul Wood indicates that it must once have been a significant size, with a girth of approximately 6.5m. There is an existing photograph in the Herefordshire libraries' collection, of the preaching cross taken in 1928 by Alfred Watkins, showing the yew tree in the background (see photograph below).

A pile of broken stones around the remnants of the tree indicate that it was once surrounded by stone seating or a plinth.

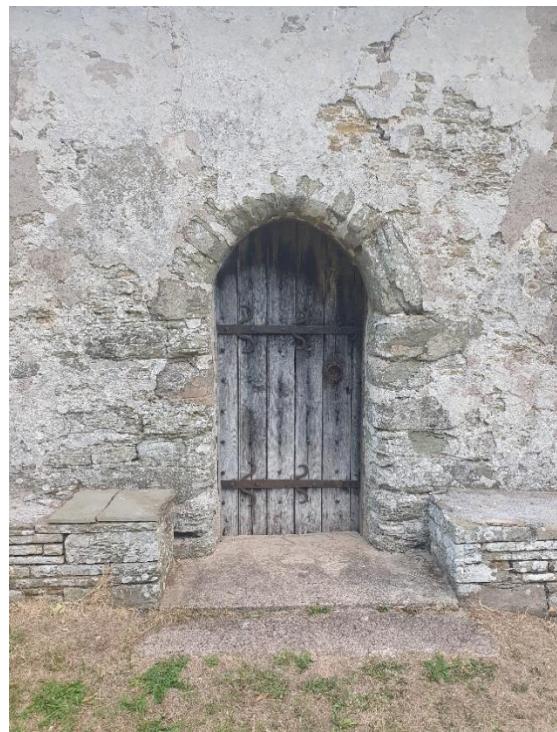
The east door

A photograph from the Woolhope transactions for 1904, reproduced below, shows a doorway in the south side of the Chancel at the Priory which is very similar to the east door.

The nave and chancel are undivided, although a low, plain wooden communion rail near the east end marks the beginning of the chancel. The east doorway is rather curious as the opening on the inner side does not match the profile of the opening on the outer side. The inner opening has chamfered jams with a three

centred arch, while the outer opening is much narrower and has a round arch. The door frame has been made to accommodate this difference, while the door itself, which is very ancient (and possibly comes from the Priory), more closely matches with the inner opening.

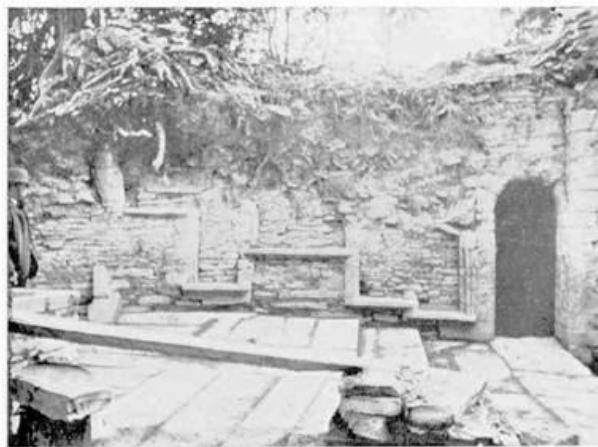
CRASWALL PRIORY. SOUTH SIDE OF CHANCEL, INTERIOR,
Showing seats for sub-deacon, deacon, double piscina, priest's seat, and credence; also
the splay of one of the Lancet windows.
No. 34. To face No. 36, between pages 272 and 273.
Photo. by R. Clarke.

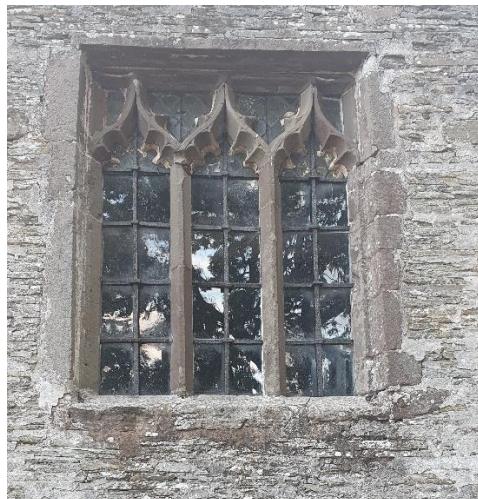
The square-headed east window is traditionally said to have come from Craswall Priory. It consists of three lights with cinquefoil heads and ogee mouldings and is of a late 14th to early 15th century date.

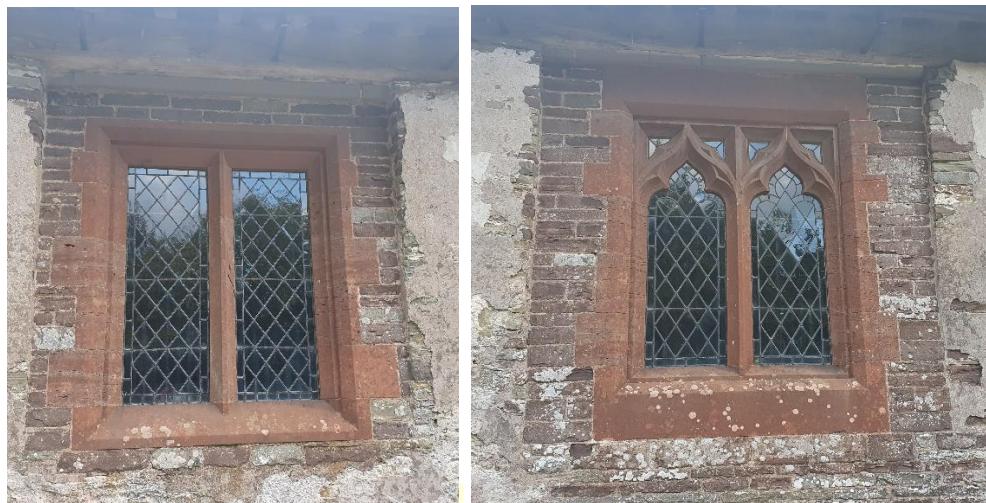
The two windows in the south wall, pictured below, were given by Mr Guy Trafford of Michaelchurch Court during restoration work carried out in 1883 by the Rev. K.R. Green using masonry from Alveley near Bridgenorth.

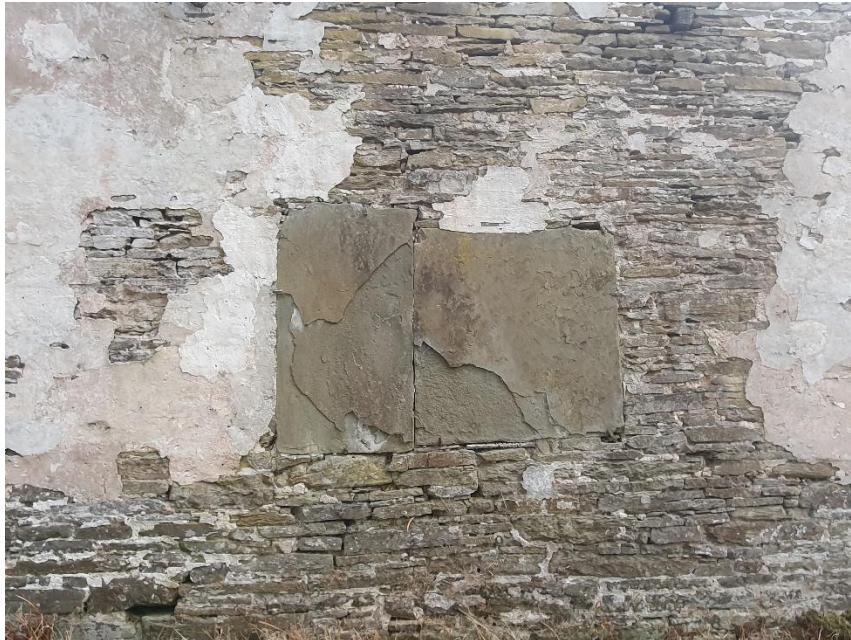
The north wall, although quite unexceptional, has several intriguing features. There are two stone slabs fixed to the wall adjacent to the fives court which were probably a scoreboard, and there appears to be more plaster left in this area than elsewhere on the wall.

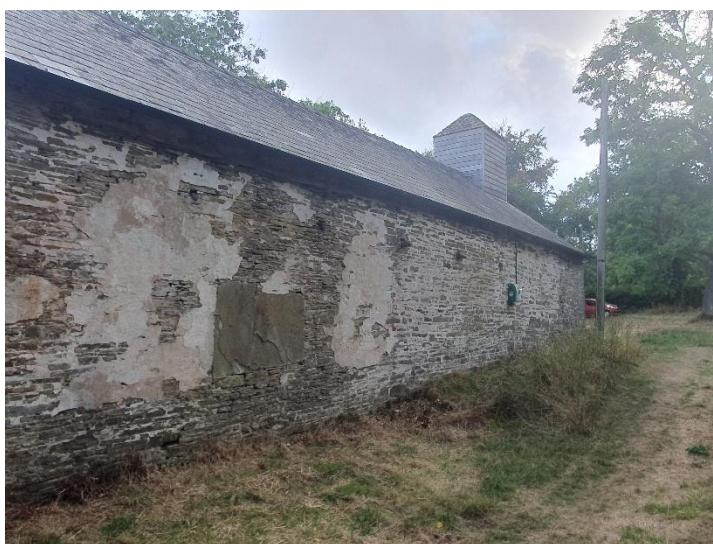
The remains of six timbers projecting slightly from the wall probably supported the roof of a lean-to structure, possibly used as stabling for horses. There is also a distinct straight joint in the north wall and the wall plate above is joined roughly at this point, as it is on the southern wall, probably indicating a later construction date for the west end of the church.

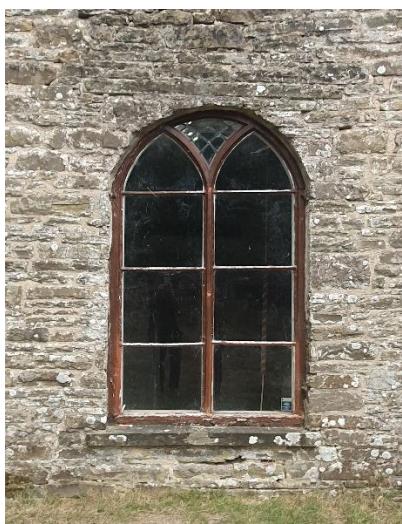
The west window.

The schoolroom retains its original flagstone floor, which is approximately 35cm higher than the floor of the rest of the building. The flags near the doorway are broken and uneven in a way typically found in farmhouse kitchens where wood has been chopped to feed the fire. It is lit by a tall window in the west wall and a rather squat, square headed window, which is generally covered by a wooden shutter, in the south wall. Interestingly, the interior opening of the west window does not match the exterior opening. The interior opening is square headed while the exterior opening is round headed.

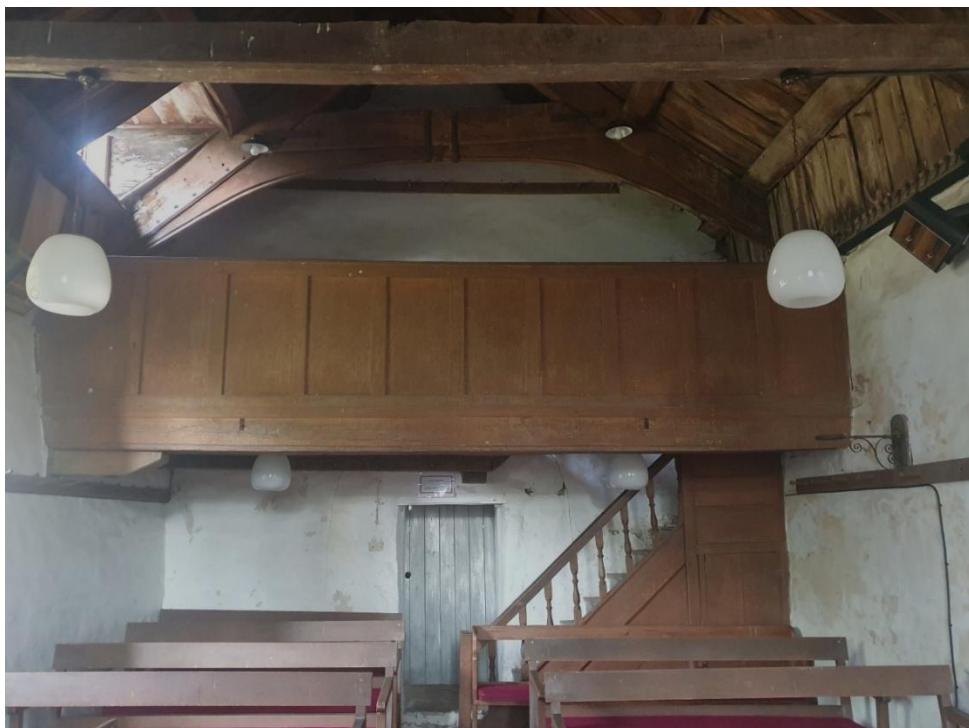
A wooden loft or west gallery, accessed by a wooden staircase, was installed against the west end of the nave possibly at the same time that the schoolroom was built. It would have accommodated a 'west gallery' choir and attendant musicians. West gallery 'ensembles' were quite common before the days of the universal acceptance of the organ as the main musical accompaniment in churches in the 19th century. A dormer window has been let into the southern slope of the roof to provide light to the gallery, and was probably added at the same time.

The roof over the nave and chancel is supported by 6 slender arched braced raised collar trusses and dates from the 15th century. The trusses may once have had tie beams, indicated by the blocks at the base of the curved braces. The remains of a painted design of running foliage can still be seen on the purlins of the eastern most bay and on the truss west of it. The roof is under-boarded with vertical oak panels with moulded ribs, and the wall plate is moulded and embattled. Three rough tie beams were added at a later date.

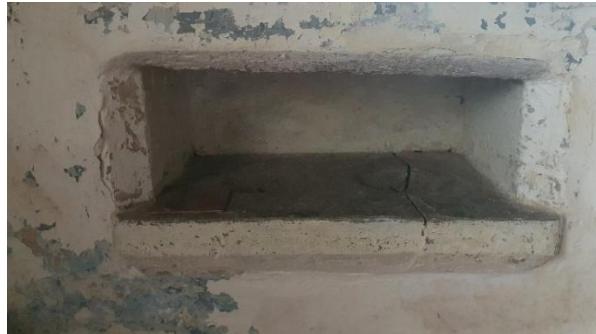
In the south wall of the chancel, in a low recess is a piscina with two round drains which may have come from Craswall Priory.

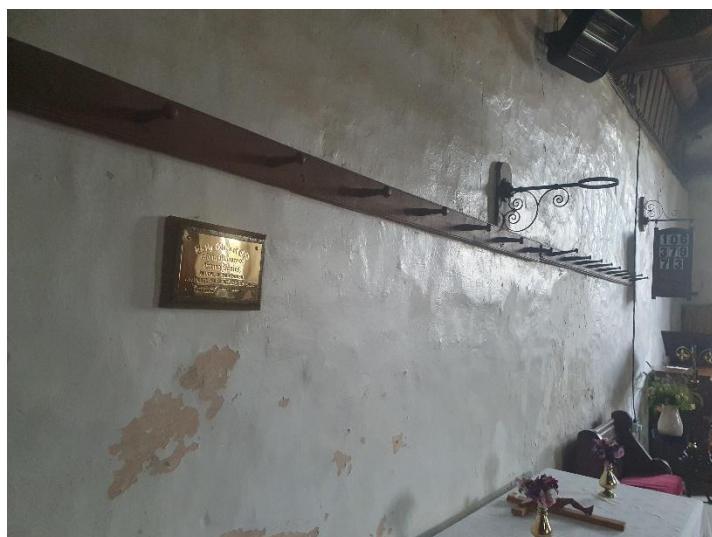
A rather curious feature of the church are the wooden batons with prominent pegs fixed to the north and south walls, as well as high up on the west wall in the loft, and on the beam against the west wall which supports the loft. Pegs for coats and hats, perhaps? There seem to be far more pegs than the number of people who can be accommodated in the nave, but perhaps people were smaller and thinner back in those days!
